Report No: DFR:00142591-1/1

Daily Field Report

Project: STRUCTURAL EVALUATION
NOBLESVILLE, IN

Date: 2/17/2023

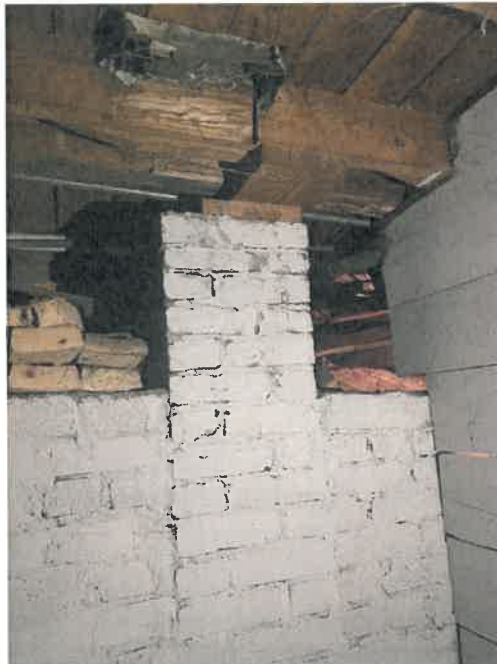
- Floor joist rotting at support columns.
- Sill plate at wall to foundation interface rotten.
- Air gaps observed to outside from utility penetrations.
- Masonry in foundation wall damaged.
- Concerns about code compliance for utilities in basement and crawl space.

Photo 1: Floor joist showing signs of rot/distress.

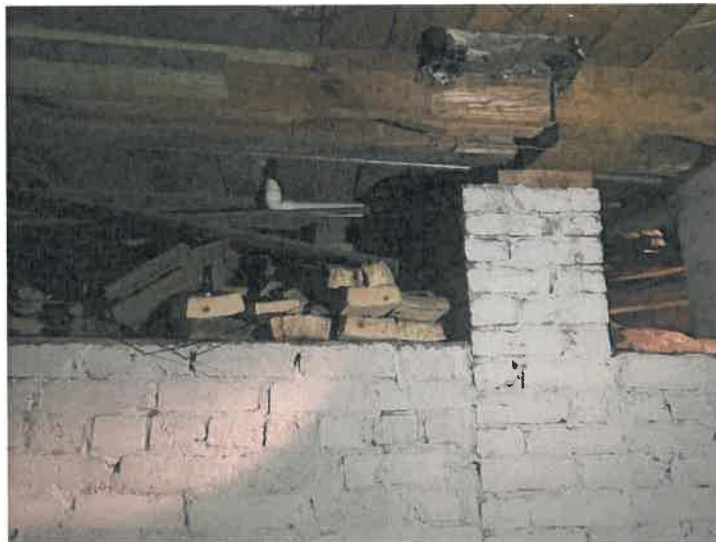
Photo 2: Floor joist showing signs of rot/distress.

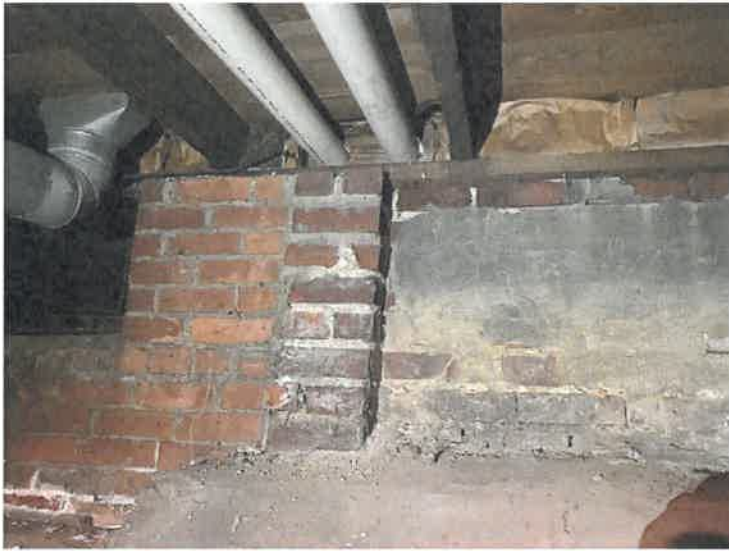
Photo 3: Utilities have open air gaps to the outside.

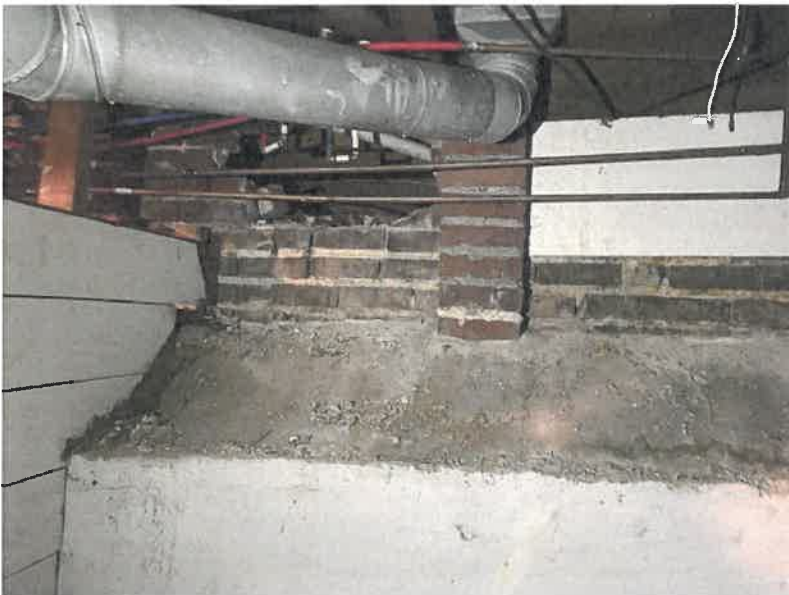
Photo 4: Distressed foundation wall in basement.

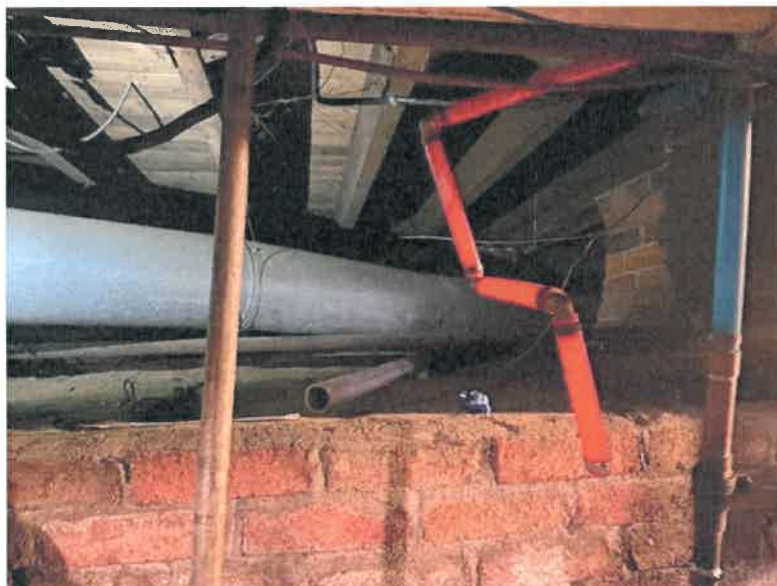
Photo 5: Concern about code compliance with basement utilities.

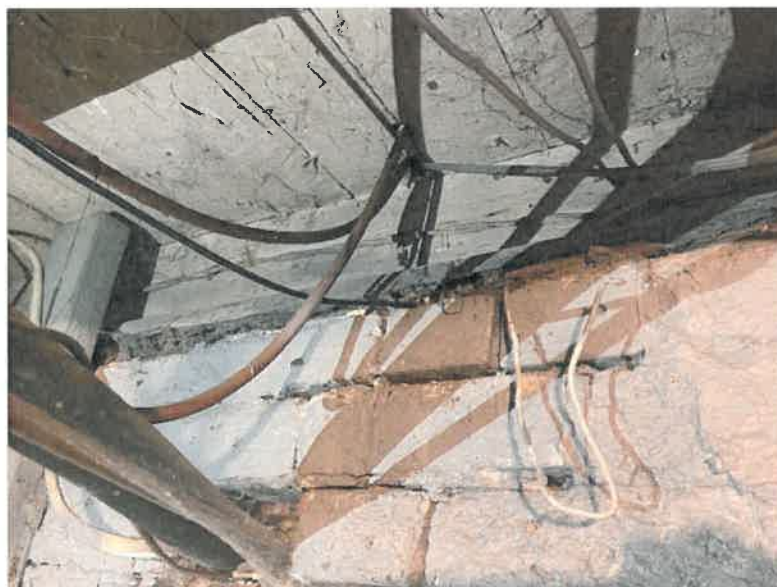
Photo 6: Sill Plate for exterior wall is rotten.

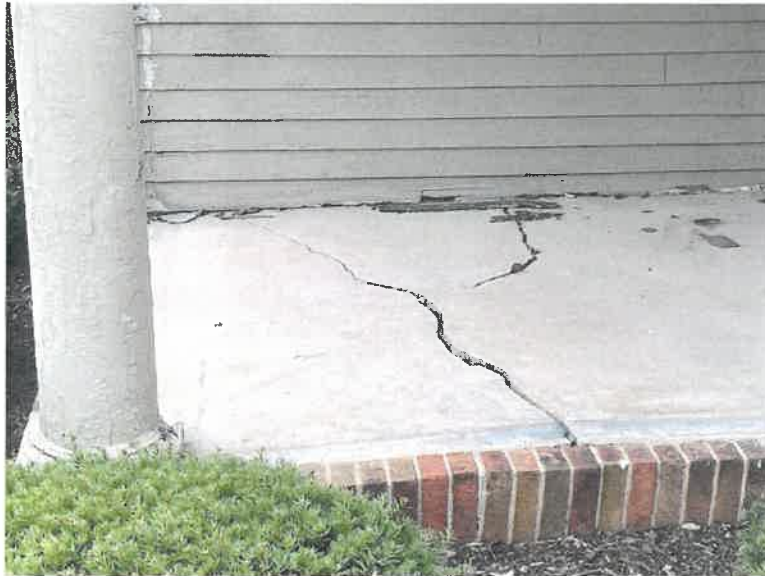
- Concrete at entrance porch has settled several inches. This concrete supports a column which is supporting the porch and roof line.

Photo 7: Front porch at entrance has settled several inches.

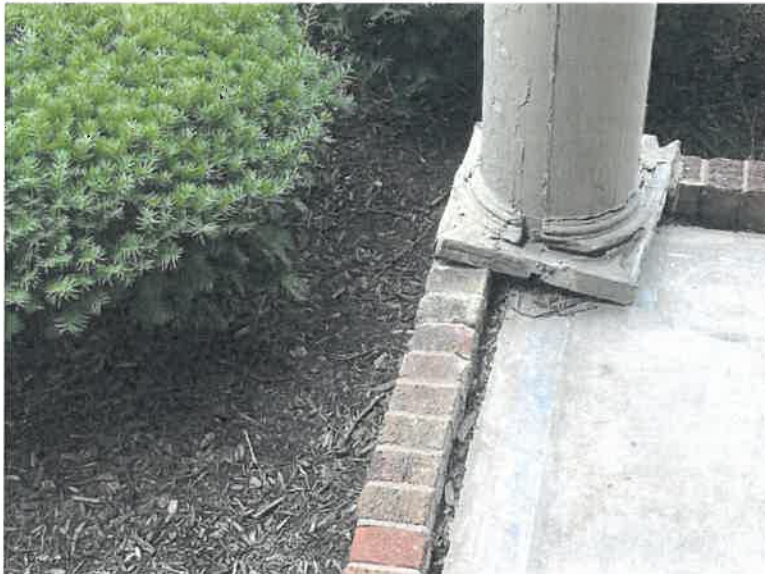
Photo 8: Due to settlement of porch, the column supporting the porch is damaged.

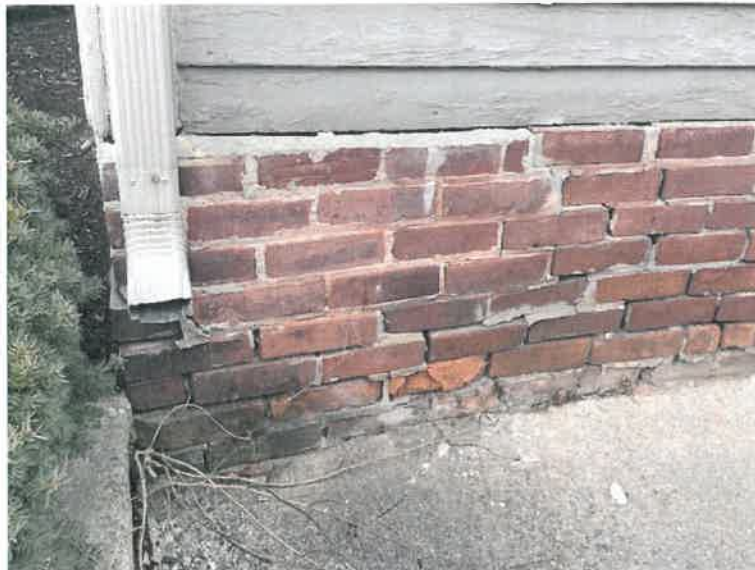
- The east foundation wall masonry is severely damaged, with most of the mortar joints eroded. Portions of this wall are completely unattached to the main structure. Some of the brick were not held in place as shown on the attached photos.

Photo 9: East foundation wall severely damaged, with mortar joints missing.

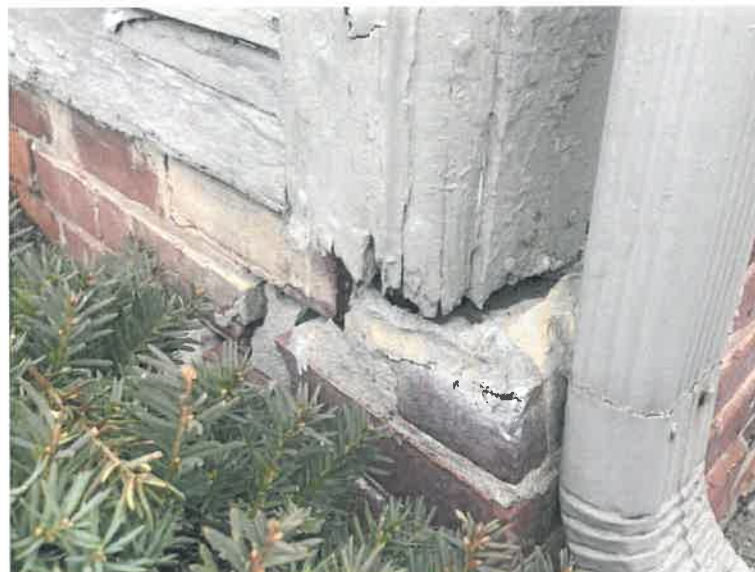
Photo 10: The foundation wall to wood framed wall interface severely damaged at SE building corner.

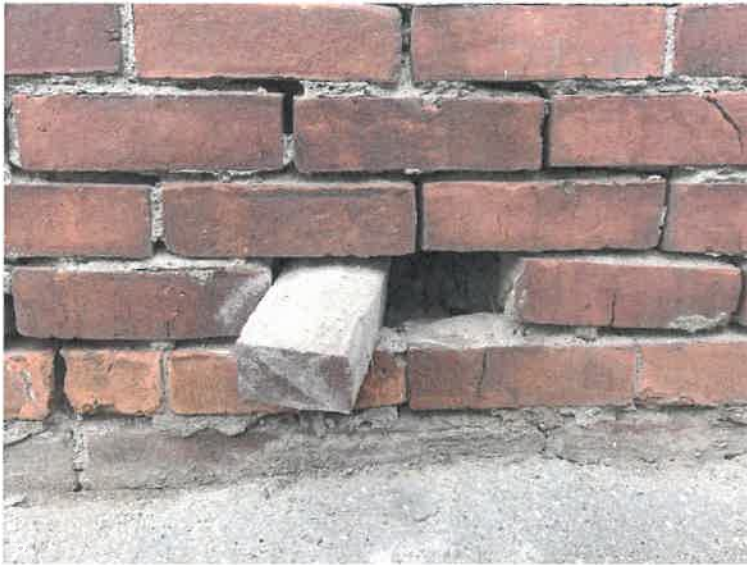
Photo 11: East foundation wall severely damaged, with mortar joints missing.

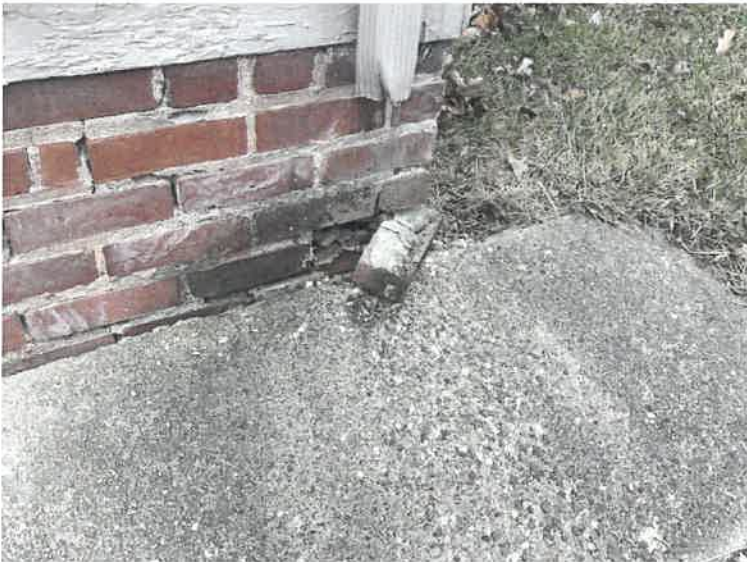
Photo 12: East foundation wall severely damaged, with mortar joints missing.

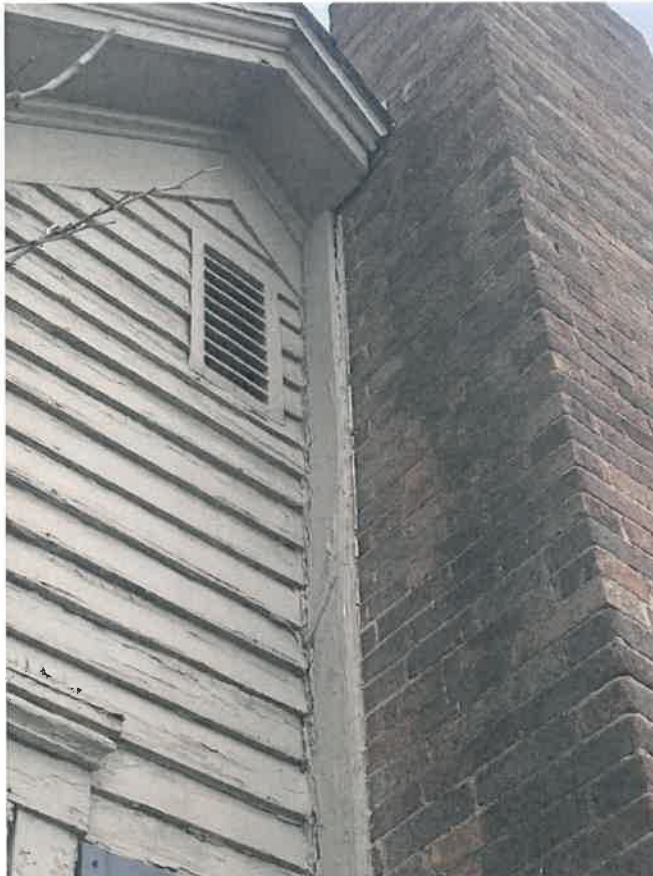
- The chimney appears to be settling, which is resulting in the chimney pulling away from the main structure.

Photo 13: The chimney is settling and pulling away from the main structure.

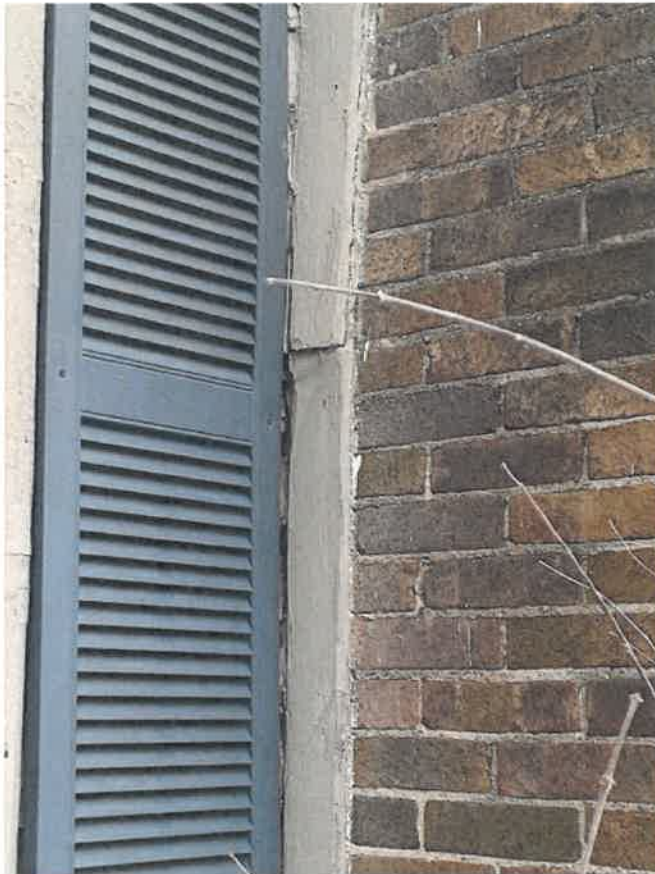
Photo 14: Another view of the chimney pulling away from the main structure.

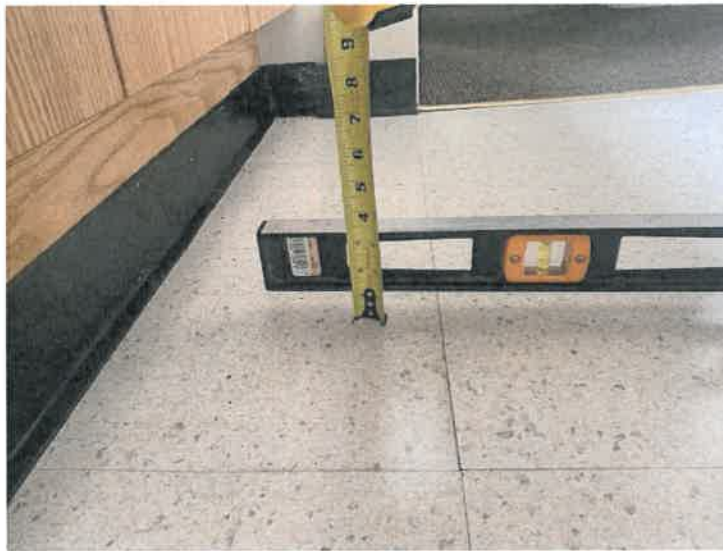
- The interior floors have settled or sagged throughout the building, with up to a 1 inch difference observed over the length of a 4 foot level.

Photo 15: Portions of the interior floor have significant movement/sag.

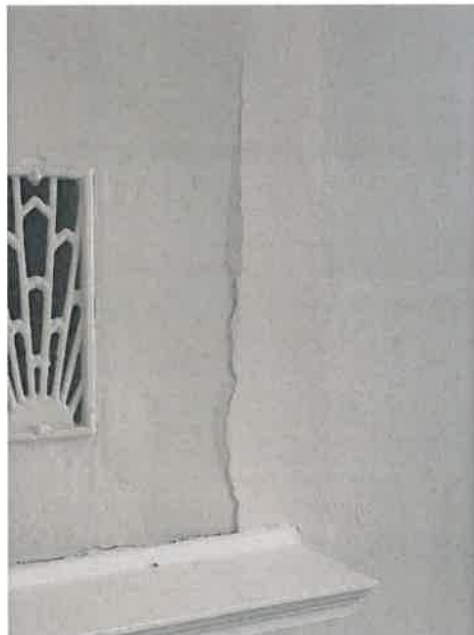
- Cracking of the interior wall was observed throughout the house, but particularly noticed at the south wall near chimney.

Photo 16: Cracking was observed throughout the interior wall, particularly the south wall. Indicates foundation settlement.

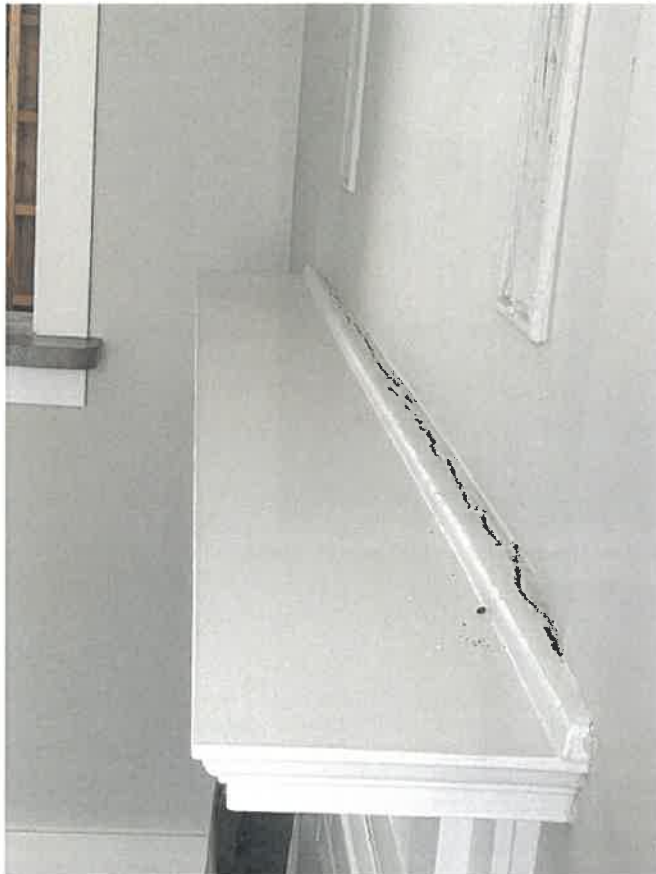
Photo 17: View of wall at fireplace mantle, cracking indicates the chimney is pulling away from the main structure.

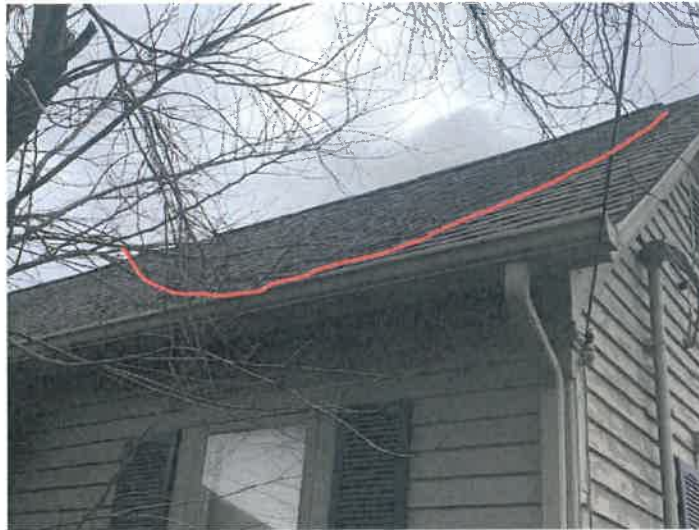
Photo 18: Roof is sagging throughout, the above view is the north side of the building.

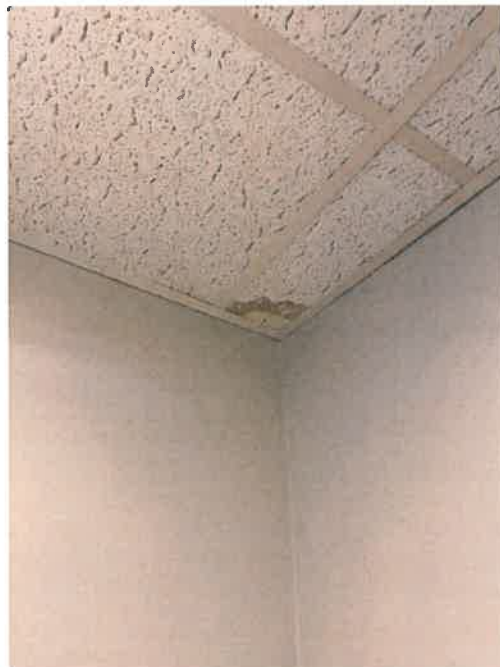
- Water spots were observed in the ceiling two locations, indicating roof leaks.

Photo 19: Water marks in the ceiling indicate the roof is leaking.

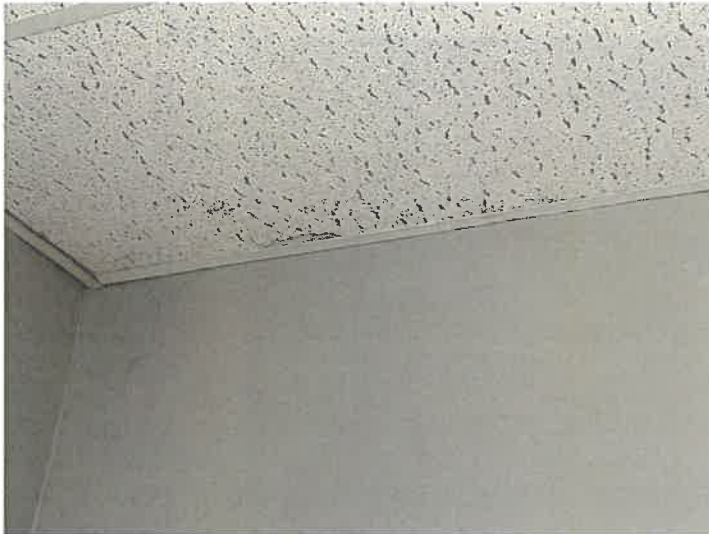
Photo 20: Water marks in the ceiling indicate the roof is leaking.

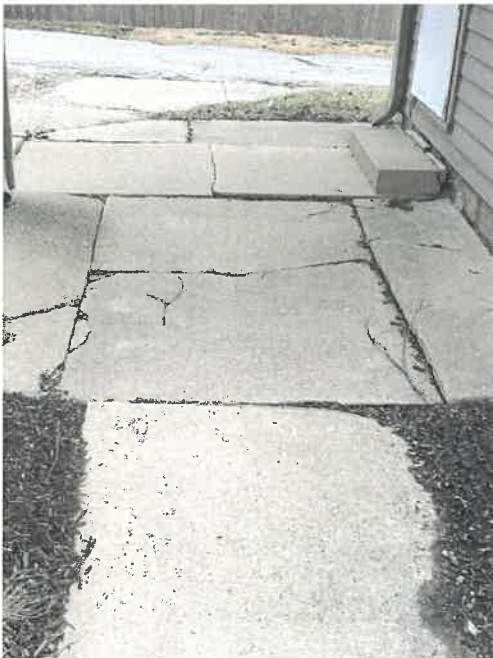
- Exterior concrete between the house and detached garage as well as the drive leading into garage has severe distress.

Photo 21: Settlement and cracking of the exterior concrete – between house and detached garage.

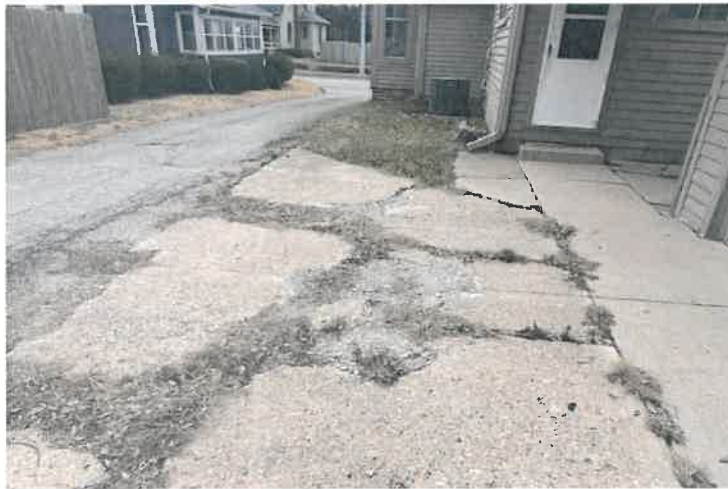
Photo 22: Concrete drive lane distressed at garage entrance.
